AMRL-TR-77-60

F/FB-111 ESCAPE INJURY MECHANISM ASSESSMENT

LEON E. KAZARIAN

OCTOBER 1977

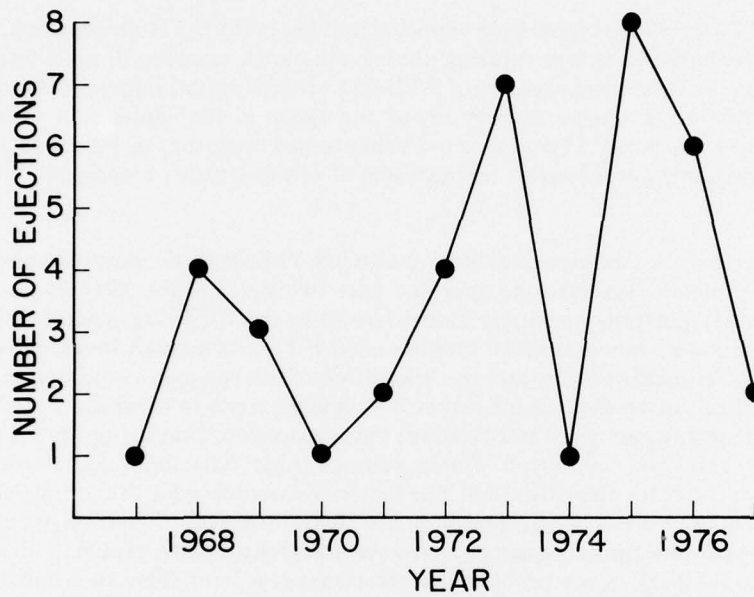
During the period 19 October 1967 to 30 June 1977, the total number of F/FB-111 ejection attempts was 39, involving a total of 78 aircrewmembers. Ejection attempts by year are shown in Figure 1. Of these 39 ejections:

Figure 1. Number of Ejections From F/FB-111 Aircraft by Year

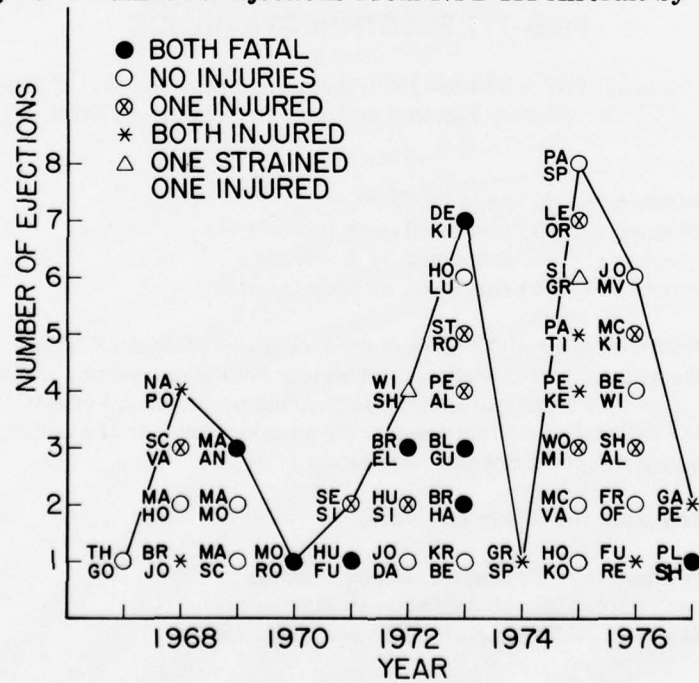
Figure 2 presents the number of ejections by year versus injury distribution. The crewmembers involved are identified. (There were no fatalities or serious injuries observed when ejection was initiated within the nominal ejection envelope and when full system sequencing occurred. All fatalities were the result of ejection initiation too late for full system sequencing to take place, or of ejection system component failure or malfunction interrupting normal sequencing.)

Figure 2. Number of F/FB-111 Ejections Versus Injury Profile by Year

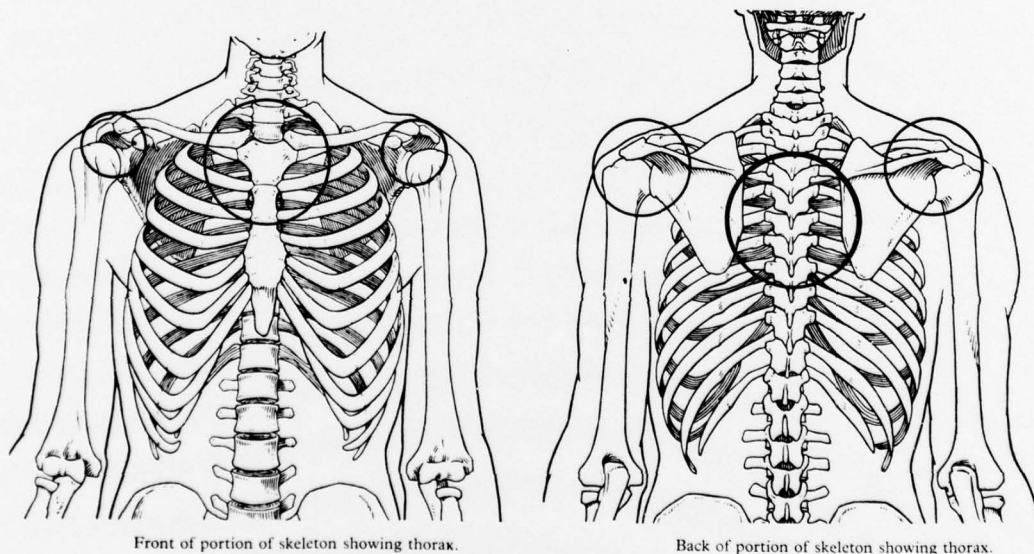
Based upon review of postejection clinical symptomatology and radiographic analysis, accident investigation board findings, aircrew interviews, and secondary follow-up postejection investigations, clinical symptomatology repeatedly exhibited tenderness or pain in the anatomical areas circled in Figure 3. In almost all instances, during or immediately following ejection or ground landing impact, the injured aircrewman complained of a more or less discomforting to severe interscapular pain in the upper thoracic spinal region. On physical examination, the spinal region involved was considerably stiff and always corresponded to subjective symptoms. In a number of cases, inspection revealed paravertebral swelling around the fracture focus that was highly painful under palpation or light percussion or both. In the more severe cases, breathing was shallow and deep breathing resulted in acute chest pain, which was partially aggravated by coughing or sneezing. Tenderness was usually present over the acromial ends of the clavicles and was also present over the acromial processes, just internal to the attachment of the coracoid ligament. Acromioclavicular separation could also be manifested. Separation at the junction of the manubrium with the gladiolus of the sternum was suspected in five aircrewmen.

Figure 3. Skeletal Sites of Common Clinical Symptomatology as a Result of F/FB-111 Ejection Forces With or Without Accompanying Spinal Trauma

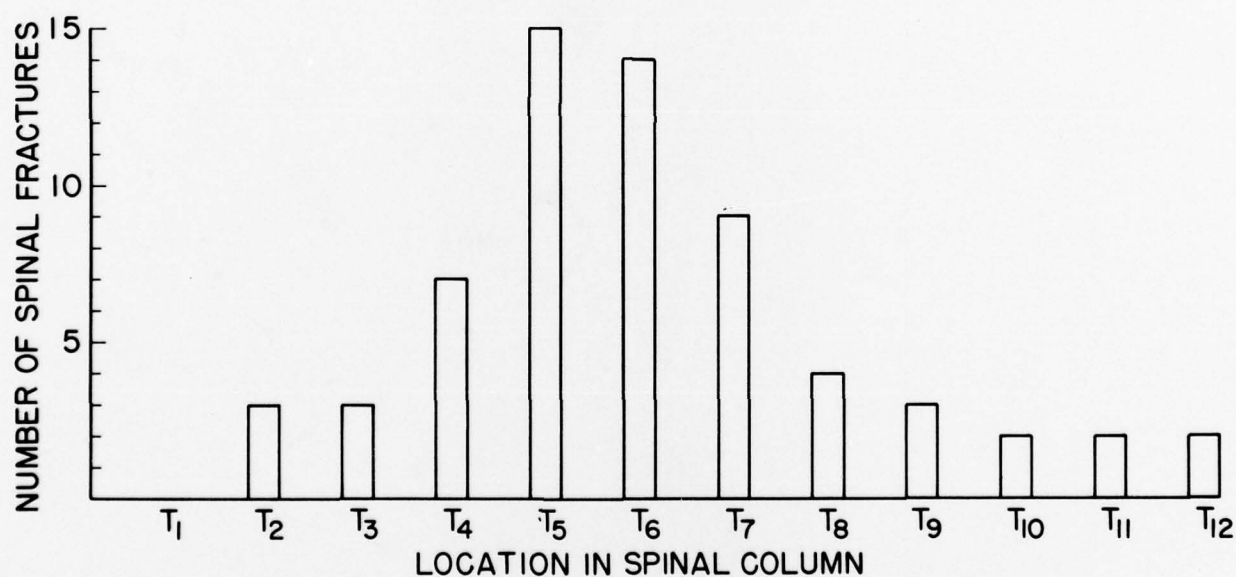
Based on tomographic interpretations, the distribution of spinal trauma as a function of spinal level for the F/FB-111 crew escape module is shown in Figure 12. The most frequently affected vertebral levels involved are those of the 4th, 5th, 6th, and 7th thoracic vertebrae, with a well defined prominence at the level of the 5th and 6th thoracic vertebrae. Figure 13 illustrates the human spinal column and identifies the region of spinal injury in the F/FB-111.

**Figure 12. Spinal Fracture Frequency According to
Location in Spinal Column**

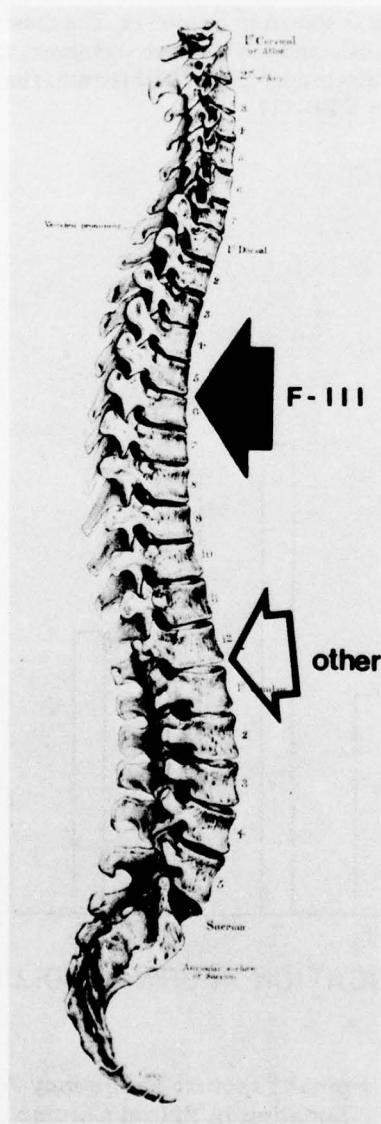
**Figure 13. The Human Spinal Column:
A Comparison of Injury Levels Between F/FB-111 Ejections
(Solid Black Arrow) and Routine Open Seat Ejections (Other Arrow)**

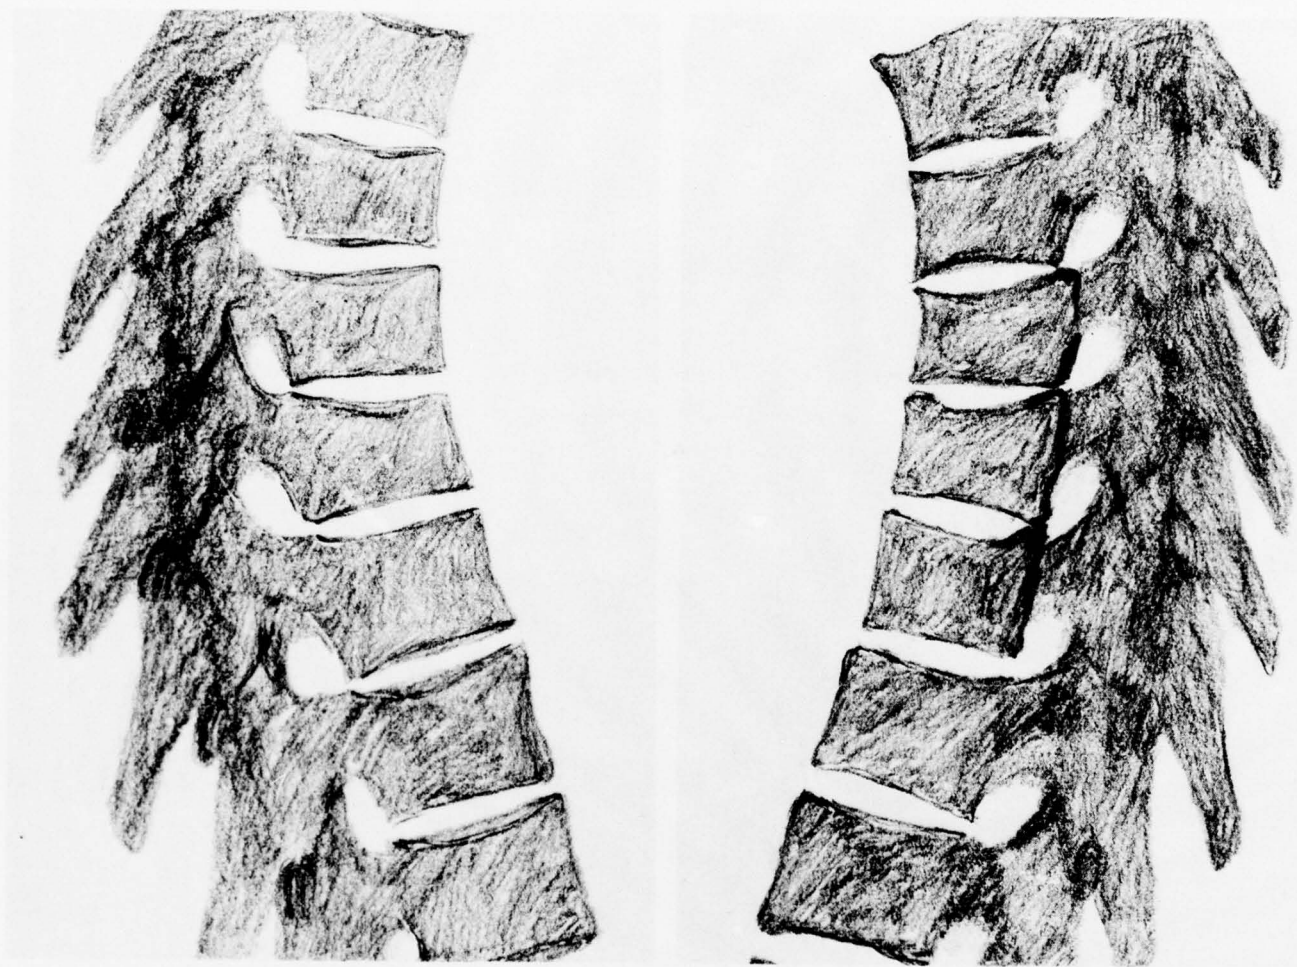
Figure 14A. Radiographs of Right and Left Lateral View of the Upper Thoracic Spine Revealing Asymmetrical Approximation of Posterior Vertebral Centrum Heights at the Level of T₄-T₅-T₆-T₇

Figure 14B. Schematic of Figure 14A

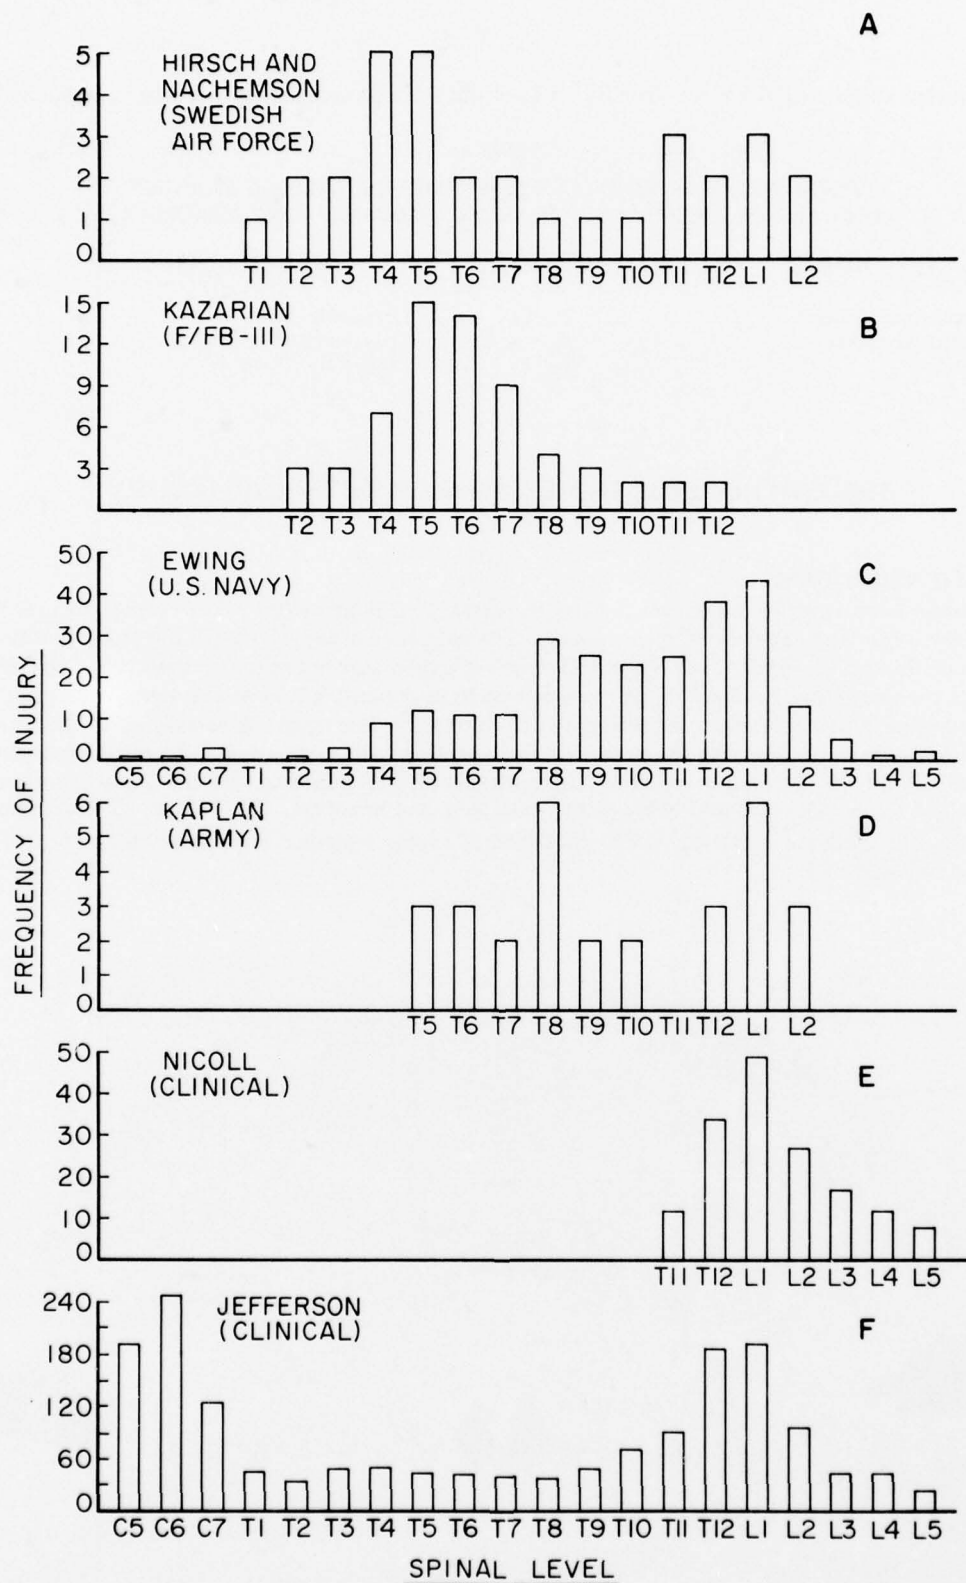
Figure 22 compares the level and frequency of other operational injury statistics to those observed in the escape module. In the open ejection seat experience, fractures occur most frequently in the spinal region T_{10} - T_{12} , excepting in a single reported series by Hirsch and Nachemson (1963), who conducted orthopedic evaluations of Royal Swedish Air Force ejectees and showed a predominance of anterior wedge compression fractures in the thoracic spine. The incidence, distribution, and level of spinal fractures reported by Hirsch and Nachemson are given. The data presented by Hirsch and Nachemson indicate multiple injury modes predominate over the length of the spinal column, whereas the F-111 data (Kazarian 1976) reflect a localization of spinal injuries in the upper thoracic column. Hirsch and Nachemson made no reference to aircraft type, restraint system, powered inertia reels, etc.

Figure 22. A Comparison Between the Level and Frequency of Operational/Clinical Injury Statistics to Those Observed in the Escape Module

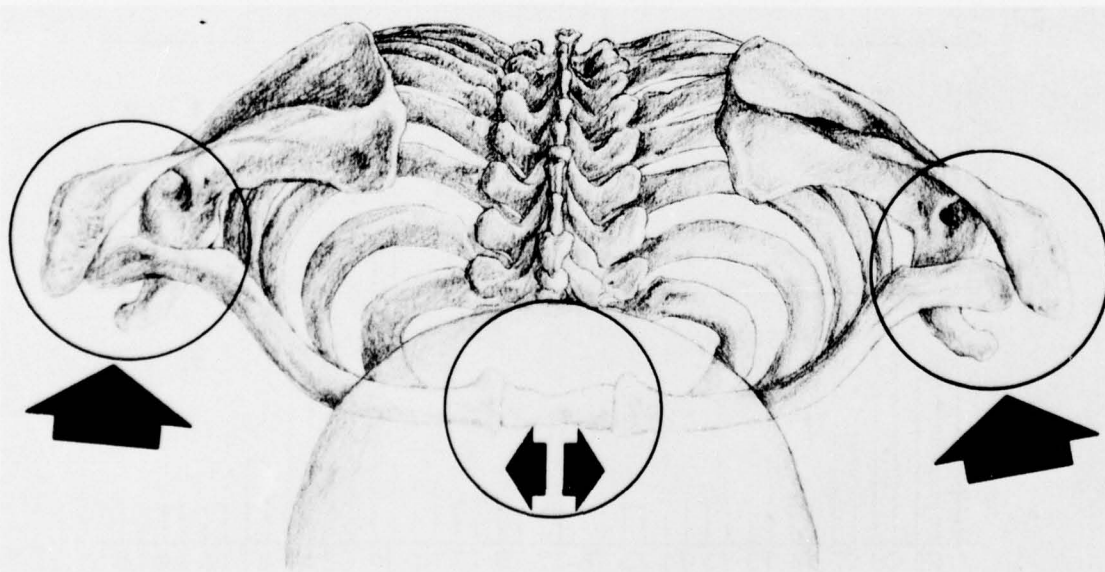
All hyperextension injuries were categorized in terms of seat geometry with respect to aircrew anthropometry, type, and severity of spinal injury. The sequence of injury was found to be as follows: on powered inertia reel retraction, the horse collar was dragged across the upper surfaces of the clavicles applying a rearward, arcing force on the acromioclavicular joints while at the same time placing the sternoclavicular joints in tension, as illustrated in Figure 23. The upper torso reacted to the retraction force by forcing the scapulae into the posterior chest wall, which restrained and locked the ends of the upper ribs into the T₁-T₇ vertebrae. Thus, the backrest formed a fulcrum for the upper position of the thoracic spine to arc into the void between the seat back and headrest. This injury is due primarily to normal thoracic kyphosis dearcing. The sequence of events required to produce this injury mode are illustrated in Figure 24.

Figure 23. Top View of Head and Torso Exhibits the Action of the Powered Inertia Reel on the Shoulders. As a Result of Powered Inertia Reel Retraction, the Sternoclavicular Joints are Placed in Tension.

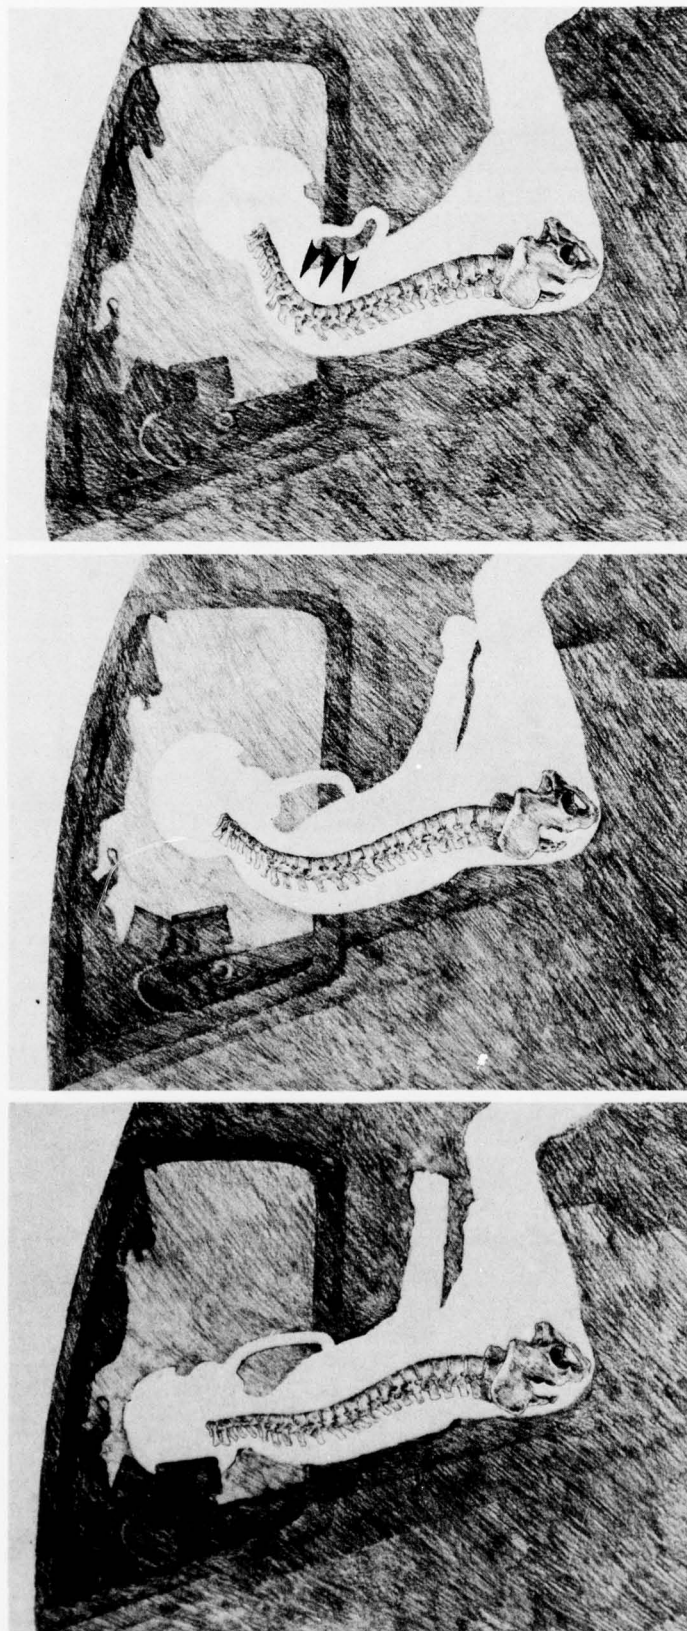
The hyperflexion spinal injury patterns experienced by all aircrewmembers were identical. I decided to scrutinize the effectiveness of the F/FB-111 harness system with respect to torso hyperflexion, resulting in the following information. The lap belt provided excellent pelvic stability; however, because the reflecting shoulder straps are anchored below shoulder level, they allow the upper torso to rotate within the fully retracted and locked harness, as shown in Figure 26. The sequential biomechanics of hyperflexion spinal injury are illustrated in Figures 27 and 28. Bursting injuries of the vertebral centrum are the result of the primary ground landing impact force applied in a vertical direction with a much smaller component in flexion.

Figure 27. Sequence of Spinal Kinesiology as a Result of Crew Module
on Ground Landing Impact

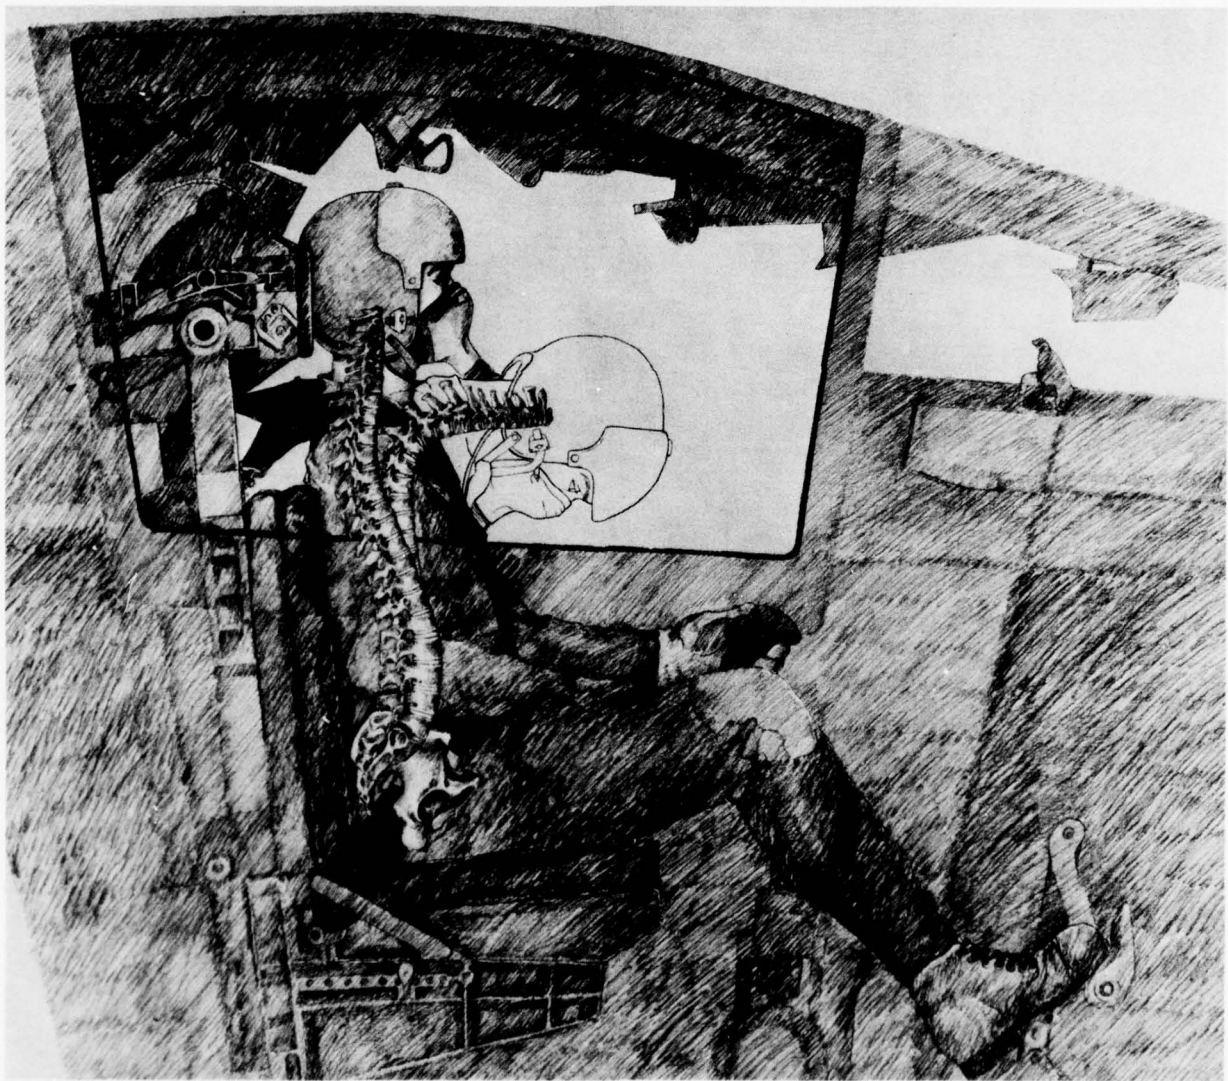
Figure 28. Sequence of Spinal Kinesiography as a Result of Crew Module on Ground Landing Impact

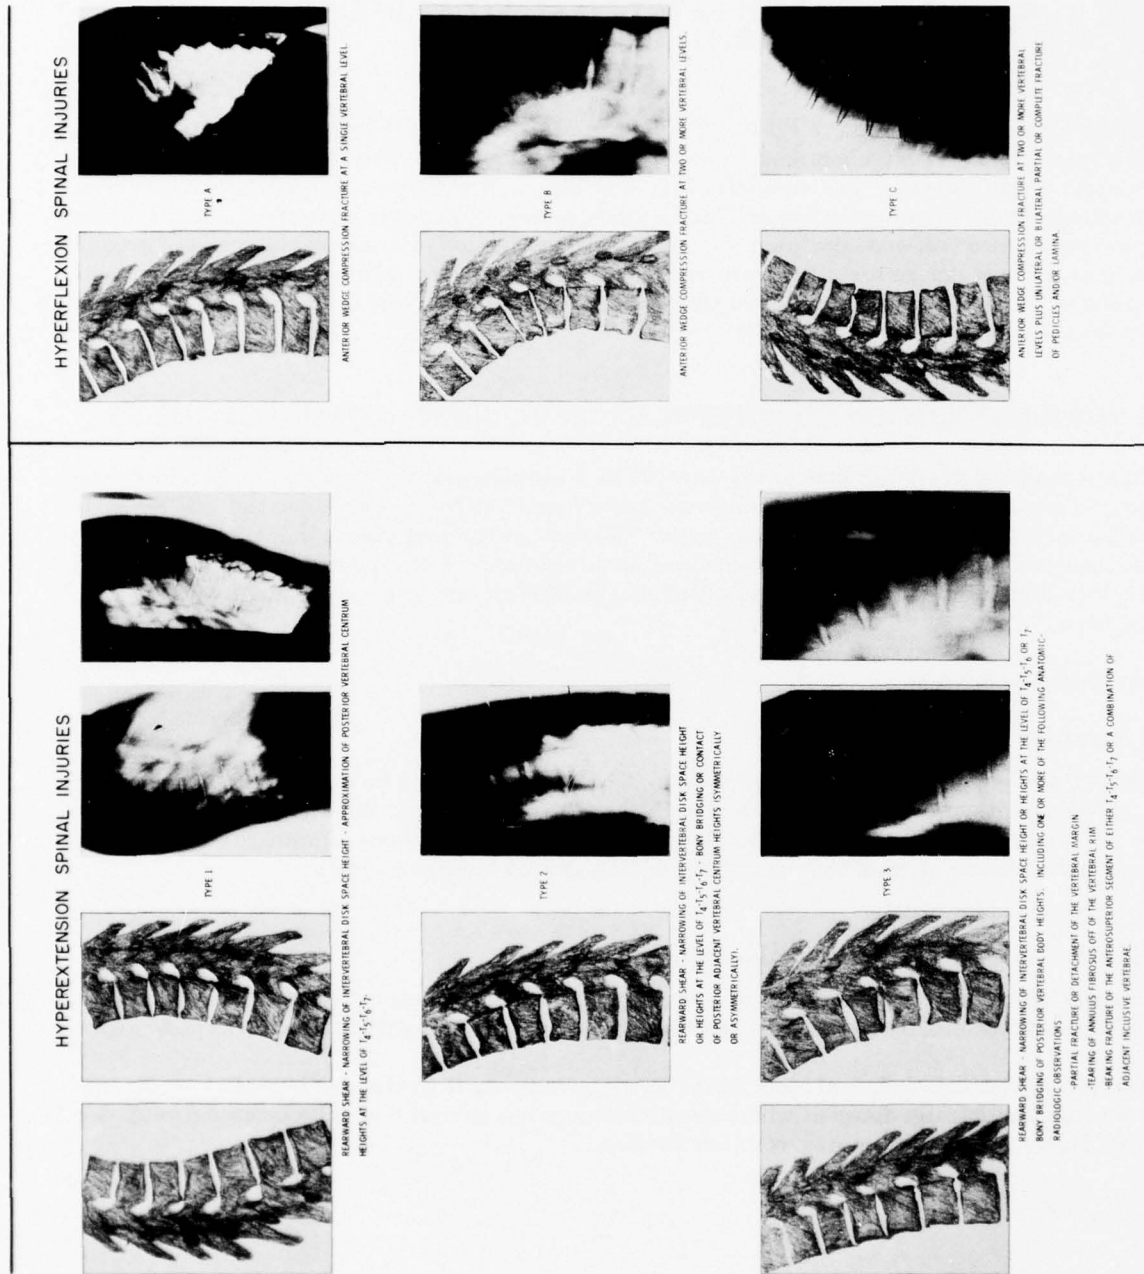
The scheme for the classification of F/FB-111 spinal injuries, shown in Figure 29, is based upon all available spinal injury roentgenograms reviewed as of 30 June 1977. The severity of spinal injury increases from Type 1 to type 3, as it does from Type A to Type C. An aircrewman may experience either one or a combination of hyperextension or hyperflexion injuries. Hyperextensions are due to the action of the powered inertia reel and shoulder strap anchors. Hyperflexion injuries are the result of ground landing impact forces and the inability of the harness to restrain the crew member. A single injury mode is identified as a Type 1, etc., or Type A, whereas, a combination injury mode is identified as Type 1A or Type 1C, etc.

Figure 29. Classification and Interpretation of Spinal Injuries Due to Ejection Forces

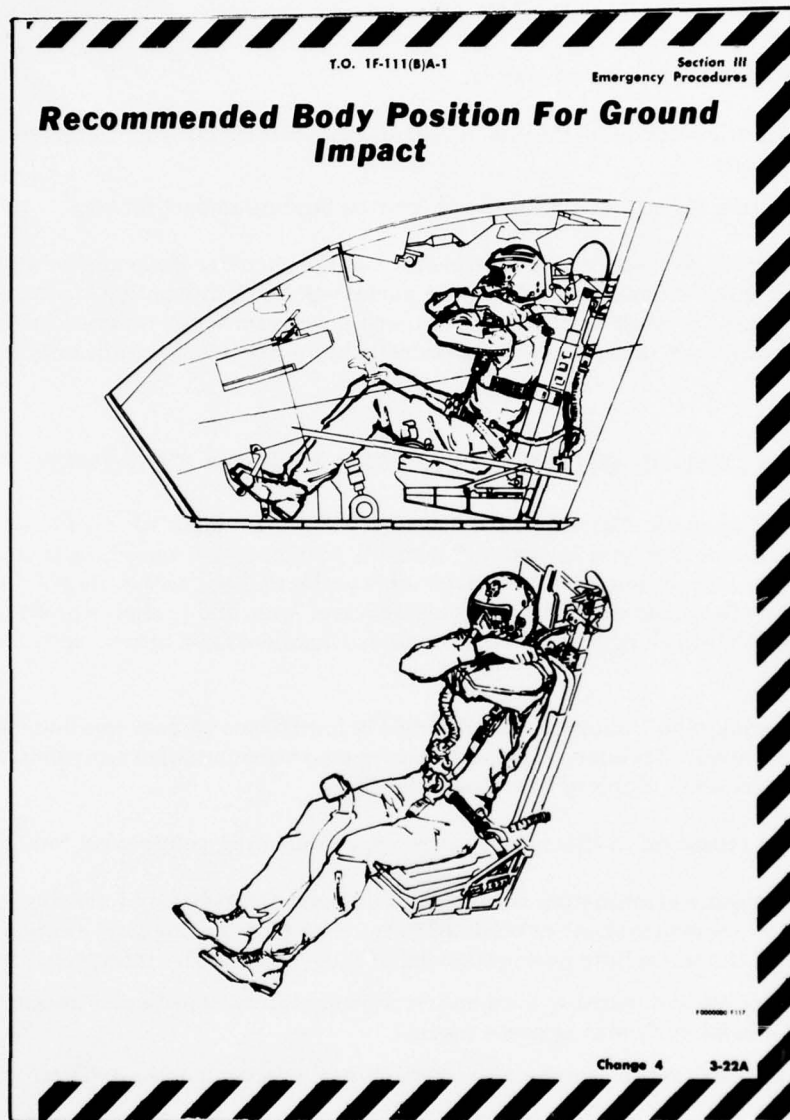
Figure 30. Technical Order 1F-111F-1SS-39

Since the initiation of this technical order (T.O.), 20 aircrewmen have ejected. No hyperflexion injuries have been radiographically detected where an aircrewman has partially or fully complied with this procedure. Hyperextension fractures continue to occur.

Following a major aircraft accident on 20 June 1975, I recommended that a new body position be incorporated into the emergency procedures to minimize hyperflexion injuries due to the $+G_x$ response of the upper torso following ground landing impact. The body position selected is shown in Figure 30. It varies in appearance depending upon crewmember anthropometry. Each crewmember is trained to be familiar with this positioning procedure as it applies to himself and to be capable of assuming it in minimal time.

- (1) Shoulder harness — locked
- (2) Seat pan — forward to optimum position. The seat pan should be moved as far forward as possible without causing leg contact with the instrument panel. With the shoulder harness locked, this motion causes a tightening of the upper torso harness and minimizes the possibility of a forward rotation of the upper body during ground landing impact.
- (3) Feet on rudder pedals.
- (4) Back and head held firmly against seat and headrest.
- (5) Arms crossed in front of head, firmly grasping the shoulder harness straps as far aft as possible. Raise elbows until pocket formed by the arms is firmly in contact with the face mask assembly.
